Historical Land Use Investigation
2824-26 North Teutonia Avenue
Milwaukee, Wisconsin

File: 311-09

Department of City Development

November 13, 2018

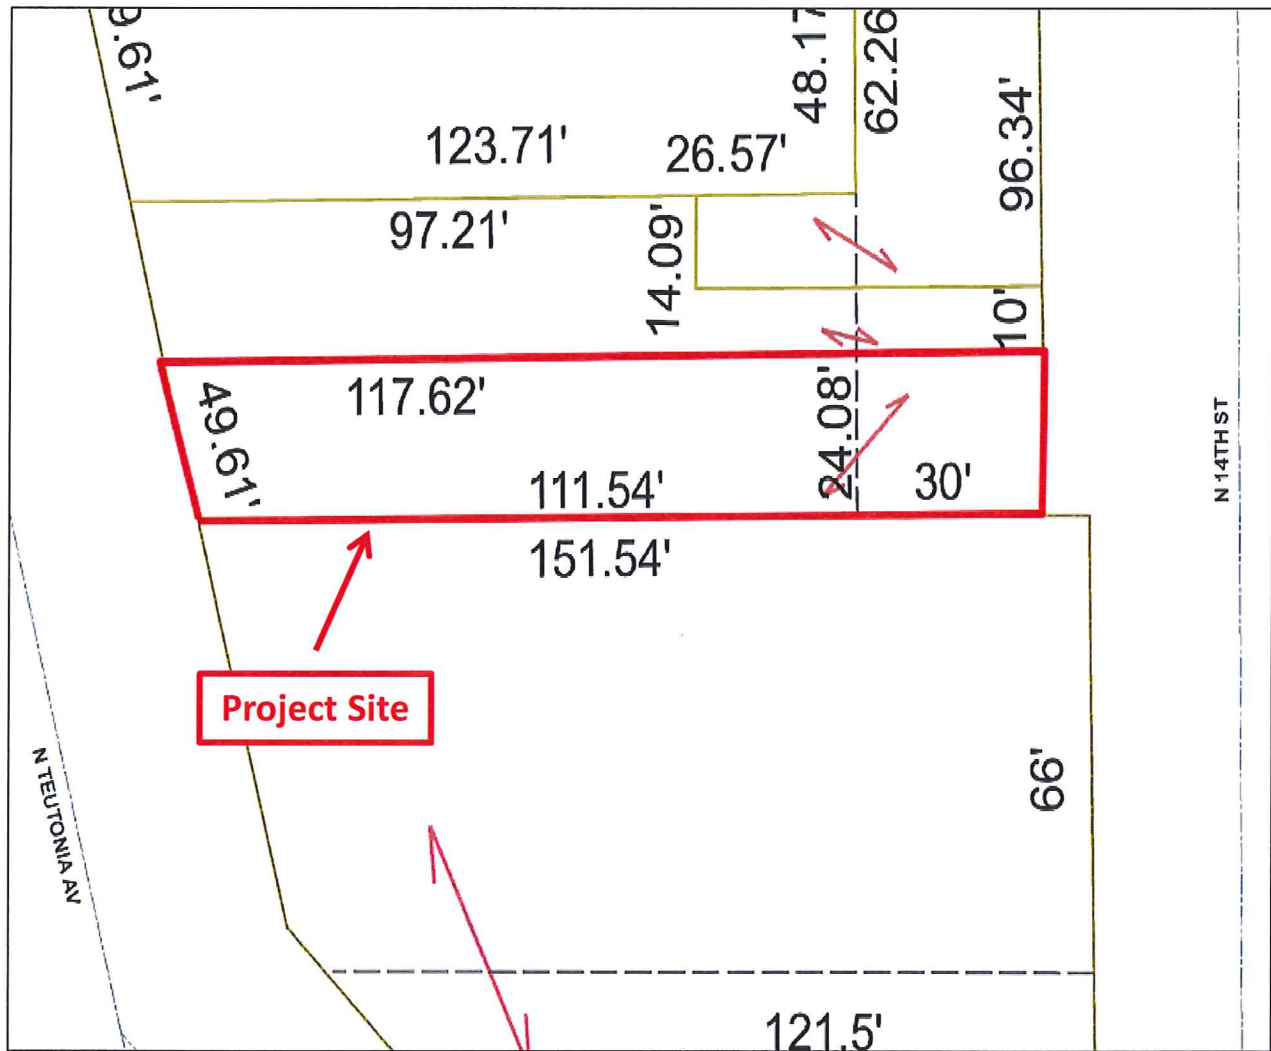
FIGURE 2

The project site is located in the City of Milwaukee on a block bound by West Hadley Street to the south, West Albany Place to the north, North 14th Street to the east, and North Teutonia Avenue to the west. The project site is developed with a 2.5 story building. **Figure 1** shows the general area including the project site, and **Figure 2** shows the project site dimensions. **Figure 3** shows a 2015 aerial photograph of the site.

Plat Map

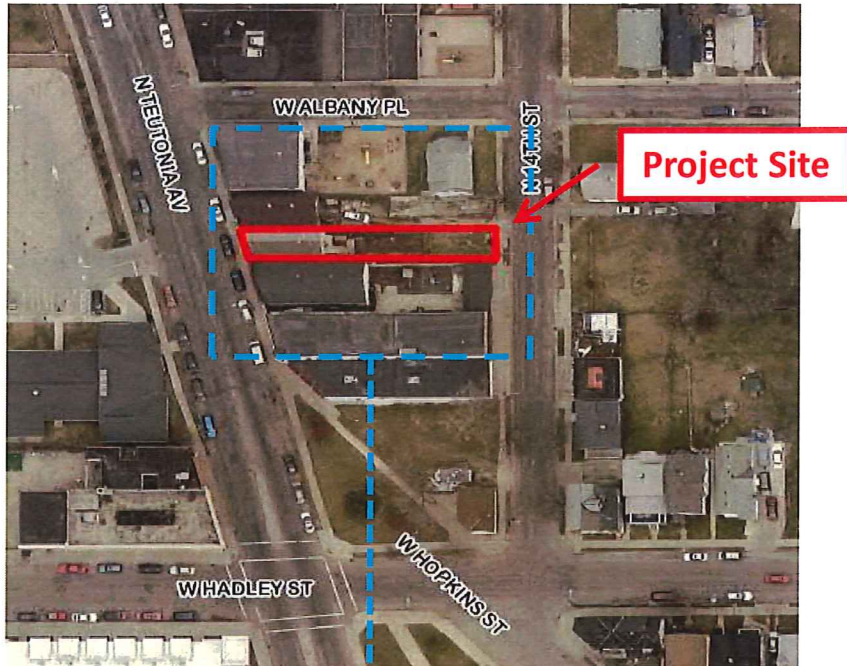
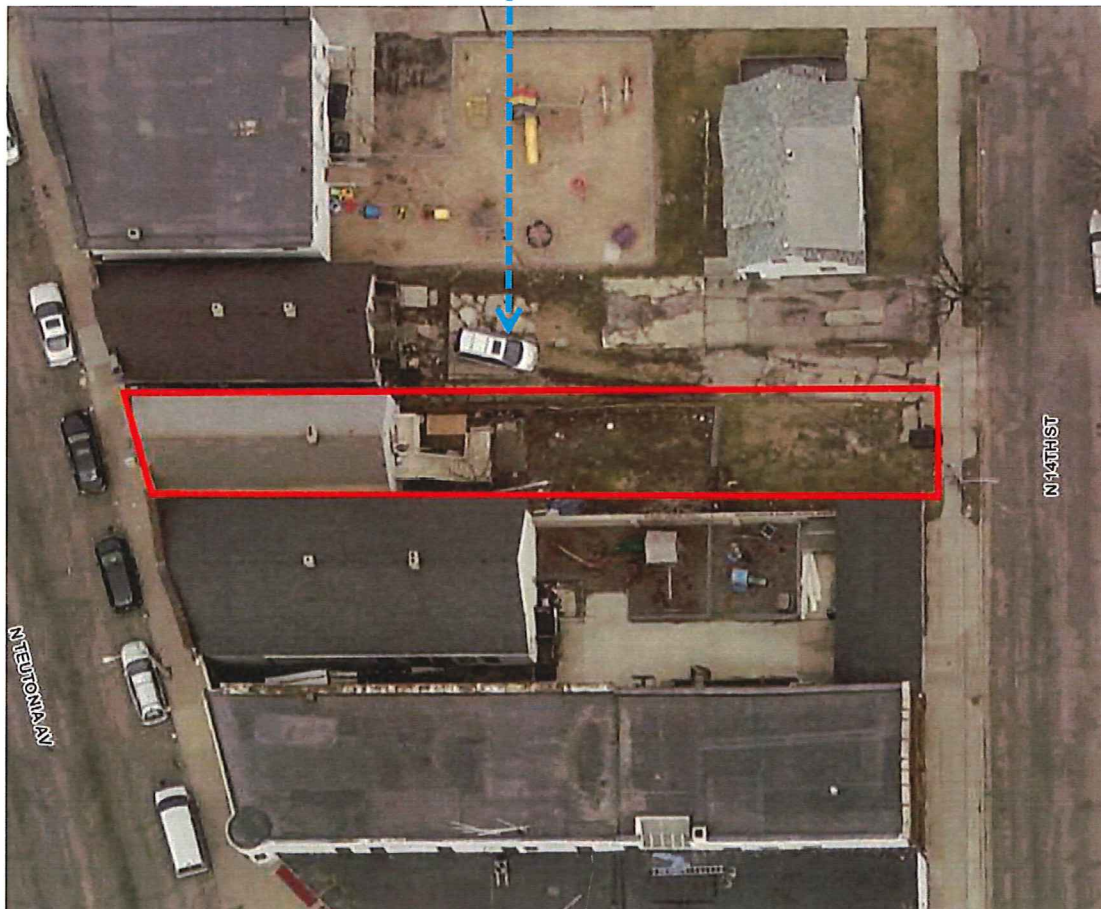
FIGURE 3

Aerial Photographs

Source: Map Milwaukee (2015 Aerial)

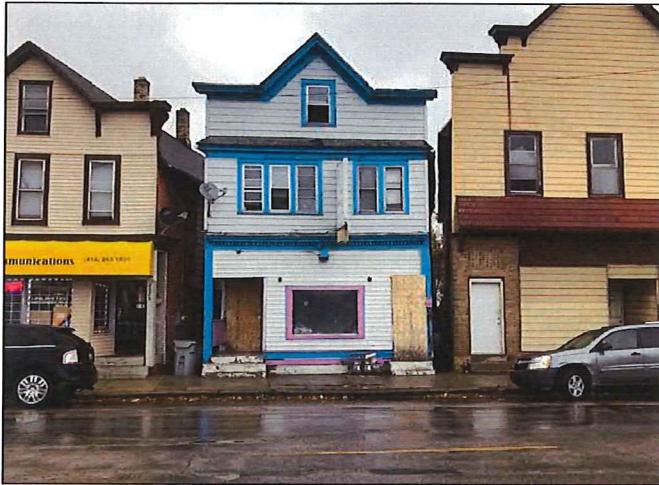
Front view of project site, looking east

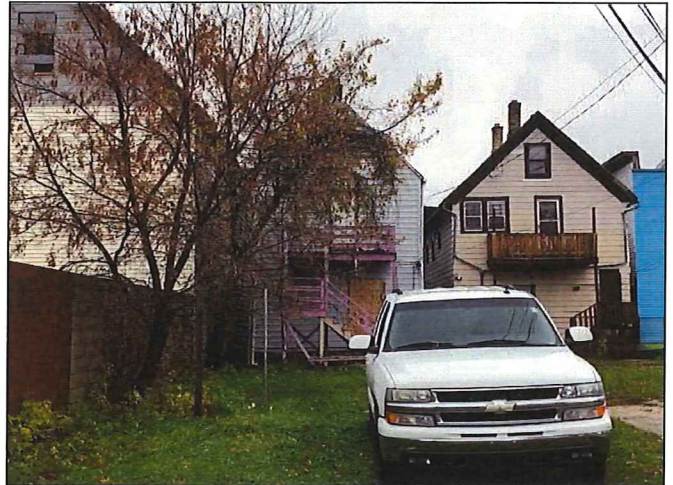
City staff conducted a site inspection on November 6, 2018. The project site was observed to be developed with a 2.5 story building. The first floor was commercial, the second floor was an apartment. There was also a basement on site. There was a small backyard as well and the grass there appeared to be in good condition.

Back view of project site, looking west

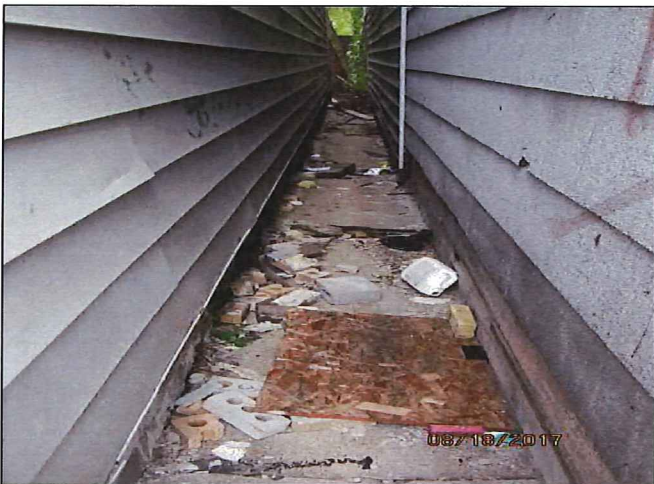
Narrow alley between project site and adjacent building

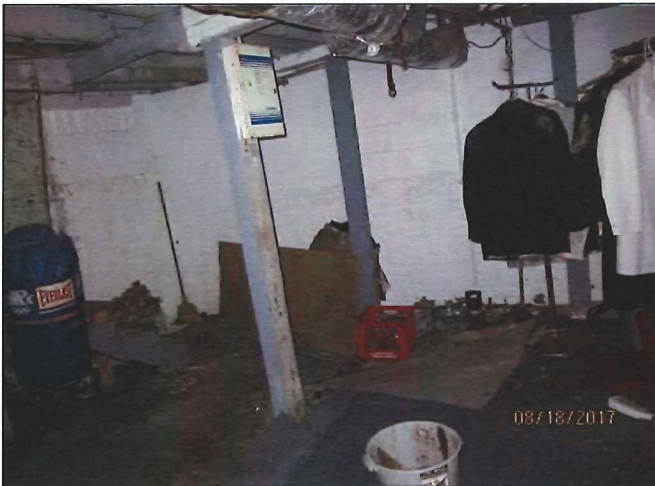
View of the basement area
